Troubleshooting

When is it time to throw in the towel?

The Bermuda Triangle

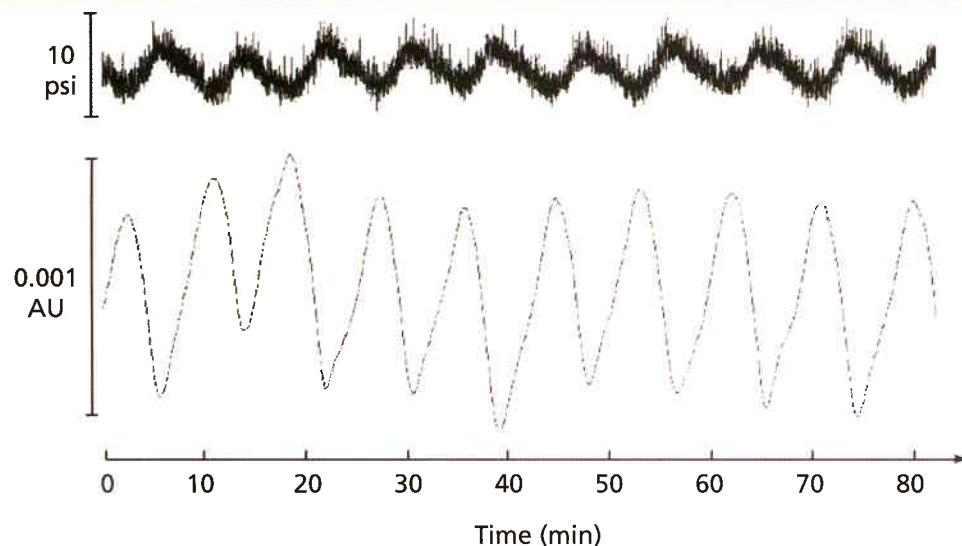
Both methods experienced the problem of baseline noise. The noise appeared as a nearly perfect sine wave with a period of approximately 7 min. The period changed slightly from day to day but was very consistent over the course of a single day. When the baseline noise was first noticed, John began monitoring the system pressure output from the controller and noticed the noise on this channel as well. An overlay of the pressure and baseline plots showed that the noise had the same period on both, but was 180° out of phase (see Figure 1). The troubleshooting process described here took place over more than a month.

Figure 1: Cyclic noise problem. (Top) Pressure monitor and (bottom) UV detector output. See text for details.

Periodic baseline fluctuations, especially when accompanied by similar pressure fluctuations, make one suspect that an air bubble might be present or some other pump malfunction is taking place. A change of the flow rate should be reflected in a change in the period of the noise if this is the case, but the flow rate did not correlate with the noise (Table I.4).

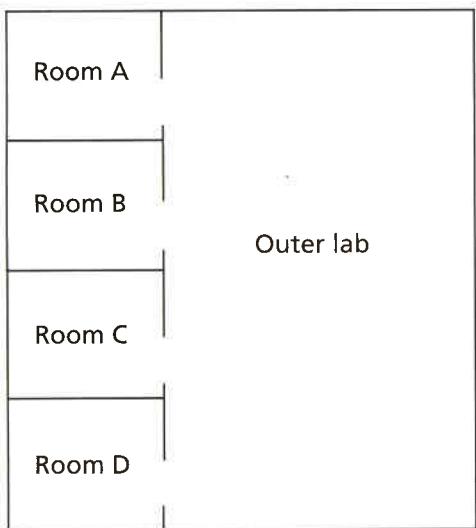
Figure 2: Laboratory layout.

To further explore the possibility that the location of the system was the problem, John put the system on a laboratory cart and moved it to various locations within the lab (Table II.3). The original location was in a 20 × 20 ft room (Figure 2, room B). When the cart was moved to the far wall of the outer lab, the noise was no longer present. It also was absent in room D. The cycle time of the noise in room C was about half that in room B, and in room A the cycle was twice as fast. As one last test, John ran a long extension cord from the far side of the outer lab, where the system had worked properly, and used it to

It was clear that something associated with rooms A, B, and C that was the source of the problem. John checked each room and adjoining laboratories for equipment that could be a large power consumer, such as centrifuges, water baths, ovens, NMR instruments, and other large equipment. Nothing could be found anywhere near the problem labs. In his searches, John popped out a ceiling tile in room A and looked into the space above the ceiling. He discovered the HEPA air filtration unit that serviced the entire building. Such a large unit must have an automatic cleaning mechanism and likely an electrostatic dust filter as well. We suspect that this is the source of the problem, but there is no way to shut down the system for testing without closing down a production line in another part of the

This is one of those problems that is encountered sometimes, for which there is no satisfying solution. It is puzzling why the other LC systems in the same room operated properly and why just this one brand and model was susceptible to the electrical noise we presume was induced by the HEPA filter. The problem serves as a very good example of how to troubleshoot a difficult problem in a step-by-step manner. A lot of time was invested in an effort to find the solution, and many of us would have given up much sooner. John discovered his lab's Bermuda Triangle and decided to switch rather than fight — he's moving the LC system to another lab. I think John deserves the LC Troubleshooting Medal of Honor for troubleshooting efforts above and beyond the call of duty!
